LNG Carrier Seawater Pump Condition Monitoring

Geoff Walker

The two motor-driven seawater pumps that were selected for monitoring are vertical, double-suction centrifugal pumps in the Main Cooling system (Figure 1).

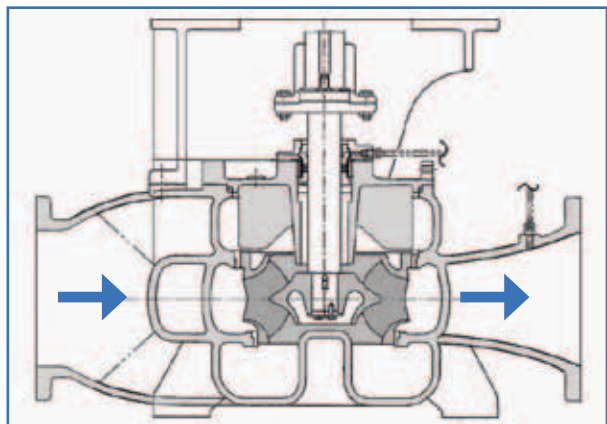
Figure 1: Cross-sectional view of seawater pump, showing the shrouded double-suction, six-vane impeller. The directly-coupled drive motor is not shown in this drawing.

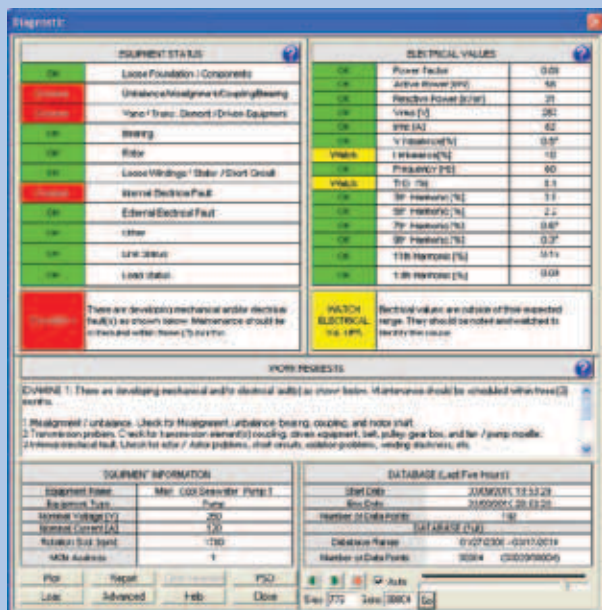
Figure 2: This diagnostic window shows the situation that existed about 6 months into the monitoring process, with level 1 alarms for Misalignment and Rotor Problems, as well as internal and external electrical faults that may be indicating stator deterioration as a result of misalignment. Current imbalance alarms have shown that this has increased to more than 10%, tending to confirm stator damage.

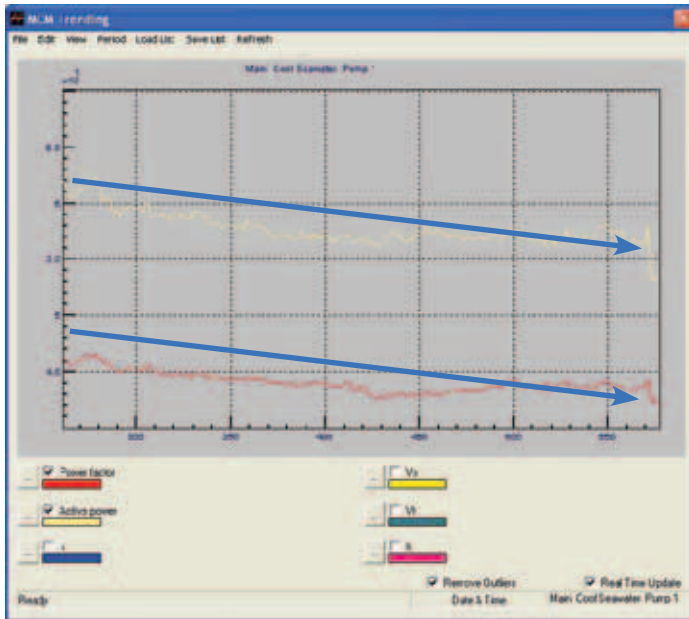
Figure 3: Trend plot showing a gradual progressive decrease in both active power and power factor parameters for Main Cooling Seawater Pump Number 1.

Interestingly, as time progressed, the power continued to decrease, but some of the indications of rubs and motor stator issues decreased, consistent with internal misalignment loads decreasing as internal wear took place inside the pump. This was followed by a decrease in the intensity of the vane pass frequency signals, indicating a loss of effectiveness of the impeller suggesting it been strongly impacted by erosion or other damage.

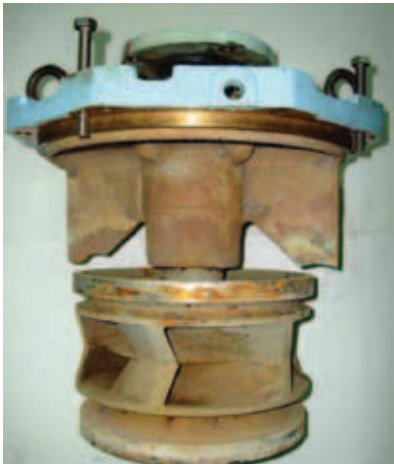
Figure 4: Pump internals after removal for inspection. Observe the significant loss of metal from the tips of the casing flow vanes (fins). Approximately 19 mm of metal was lost in two places. Fin thickness was also reduced from the original dimension of 7 mm to 4.5 mm. It turned out that the Vane Pass anomaly was produced by this damage, rather than by deterioration of the impeller.

the assessments provided by the AnomAlert unit. When the upper casing cover was removed, it was very apparent that the flow vanes (fins) had suffered significant metal loss due to erosion (Figure 4). The impeller had light fouling, and the wear rings had eroded, causing a reduction in performance by allowing recirculation flow. A small hole had also eroded in the pump casing where a flow disturbance was produced by a wear ring retaining screw (Figure 5).

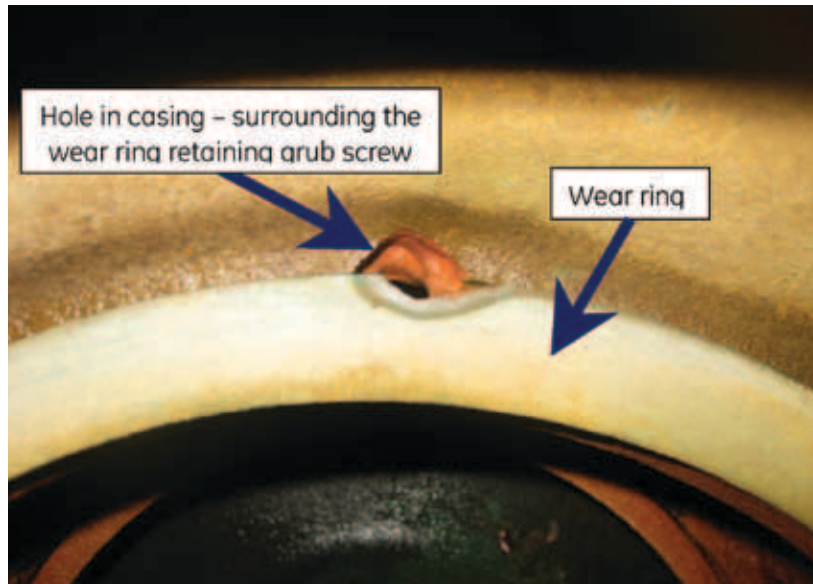
Figure 5: Upon disassembly, it was discovered that erosion had produced a hole in the pump casing, at the point where a wear ring retaining screw caused a localized flow disturbance.

- The impeller was in good condition, so it was simply cleaned and reused (Figures 6 & 7).
- The eroded wear rings were replaced, restoring normal clearances and pump efficiency.
- The hole in the pump casing was repaired using cold resin techniques, preventing further deterioration of the casing at that location.
- Although the casing fins were heavily eroded, they were not significantly impacting performance, so the casing cover was reused without repairing the fins.
- Cost of repairs was approximately 10% of the “normal” cost of pump replacement associated with the previous Run-To-Failure (RTF) regime.

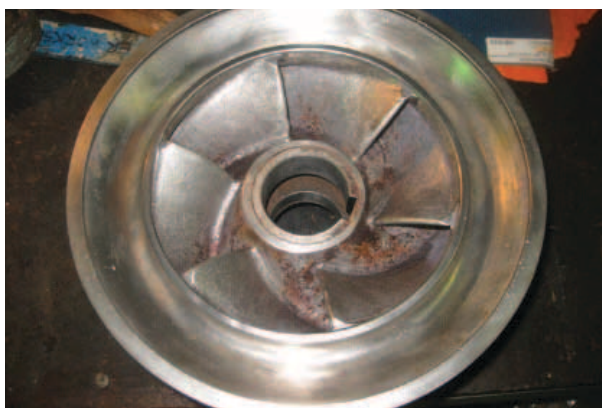
Figure 6: Impeller after cleaning. Axial view into one of the impeller eyes (suction).

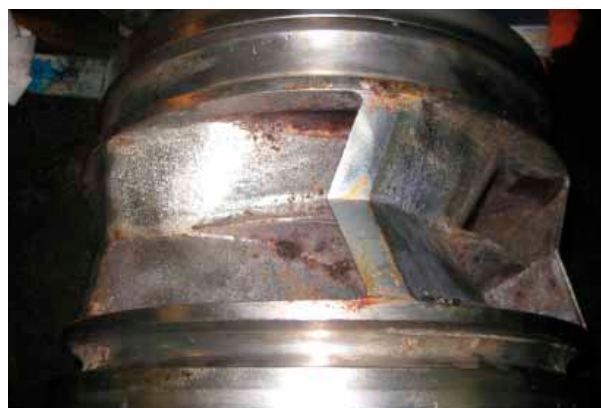
Figure 7: Impeller after cleaning. Radial view of the impeller vane tips (discharge).

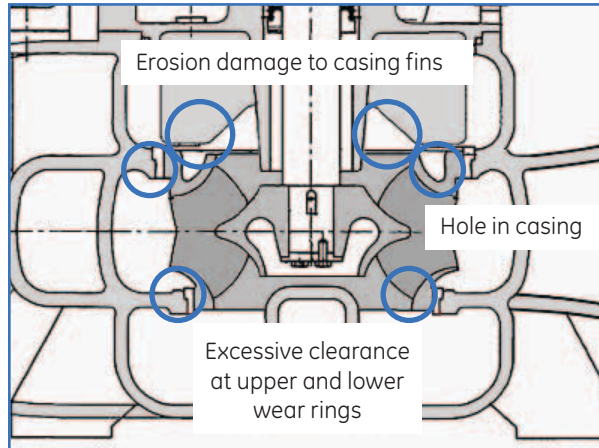
Delivering a succinct and informative maintenance report at the end of the trial, Artesis stated that there were signs of wear ring damage and a loss of performance consistent with a hole in the pump casing (Figure 8). The subsequent replacement of wear rings and repair of the casing hole helped return the efficiency of the pump to normal. It was also reported that fixing the hole in the casing where the retaining grub screw for the wear ring is located saved the pump casing from further deterioration. Although the pump casing fins suffered a heavy loss of material during the trial, and it was advised that these should be repaired, this was not essential for pump operation. No damage was recorded to either the rotor or stator of the drive motor and none was suggested from the trial data

Figure 8: Identified sites of pump condition degradation.
