ALTERREX* Rectifier Replacement

fact sheet

GEA-14887 (05/07)

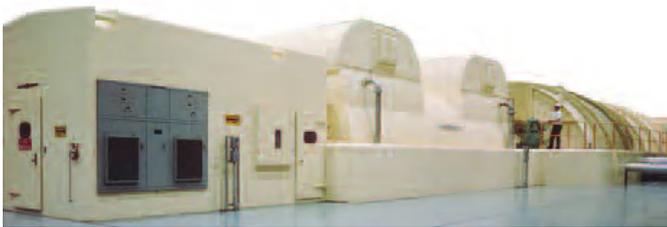
ALTERREX* excitation systems were supplied with large steam-turbine generators that shipped between 1965 and 1992. The system consisted of a second AC generator, commonly referred to as the Alterrex alternator, attached to the main unit shaft via a rigid coupling. The output of the Alterrex was then rectified by a set of fixed diode-based rectifier bridges installed in the Alterrex alternator "doghouse." The system utilized a dedicated loop from the unit stator water-cooling system to cool the individual diode bridges. The bridges consisted of 12 or 24 press-pack diode modules delivering high performance and reliability in an efficient form factor made possible by the liquid cooling.

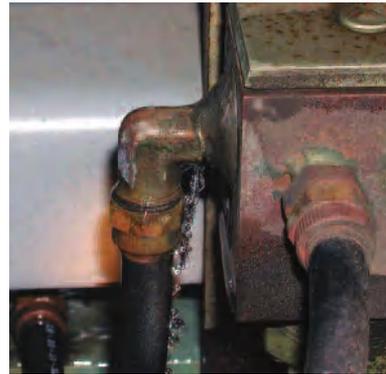
Unfortunately, the non-conductive de-ionized water used by the stator is corrosive. The corrosive nature of the cooling water and years of continuous high velocity flow are the root-cause of most of today's maintenance problems. Specific maintenance issues associated with the system cooling components include: thin walling/erosion of the copper pipe used for supply lines and manifolds; fitting erosion; braze leaks; Teflon (black) tubing cracks; O-ring hardening; gate valve corrosion; and copper migration within Teflon® (white) tubes. Aging electrical components are also driving increased maintenance, as diode indicating lights used for diagnostics fail more often than the diodes, causing false failure indications and wasted maintenance time.

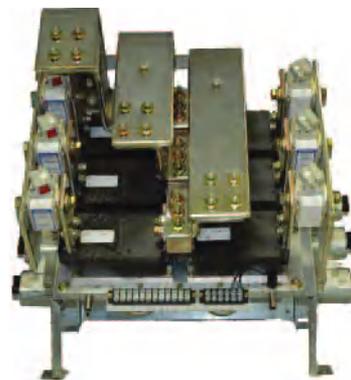
After more than a 30-year average service life and advances in material technologies, the original diode bridges can be replaced with a modern power conversion system. GE has custom-designed a new EX2100 Rectifier Bridge for a one-for-one replacement of the original rectifier and mounting in the original cubicle. The new diode bridge is available with a range of on- and off-site services to ensure the right level of services to meet plant personnel, budget and outage limitations.

You retain your existing cubicle, overhead bus-work, and cabinet doors. We replace the diode rectifier, refurbish the on-line repair switch, replace the manifolds with stainless piping and valves,

and provide a new, more reliable diagnostic indicator panel. GE is helping you reset the clock on the Alterrex diode system.

- Minimum water carrying parts
 - One aluminum heat-sink (with a single continuous stainless-steel tube)
 - Two ball valves
 - Four industry standard hydraulic hoses
- High-reliability materials: no more copper, brass, or bronze *anywhere*
 - Only stainless steel or durable, stainless braid protected elastomer hose
- High-quality valves and fittings: quick disconnect connections and no rust-prone gate valves
- Standard hydraulic fittings: off-the-shelf products, not high-cost long cycle components
- Easy to repair with all front accessible components
