Benefits of using GE's Bently Nevada* 3500 Series Machinery Monitoring System

BASF, the world's largest chemical producer headquartered in Ludwigshafen, Germany, experienced an unexpected shutdown and high vibration alarm on a steam turbine train. Using GE's Bently Nevada 3500 Series Machinery Monitoring System, BASF was able to quickly diagnose the problem and restart the machine. No repair was required.

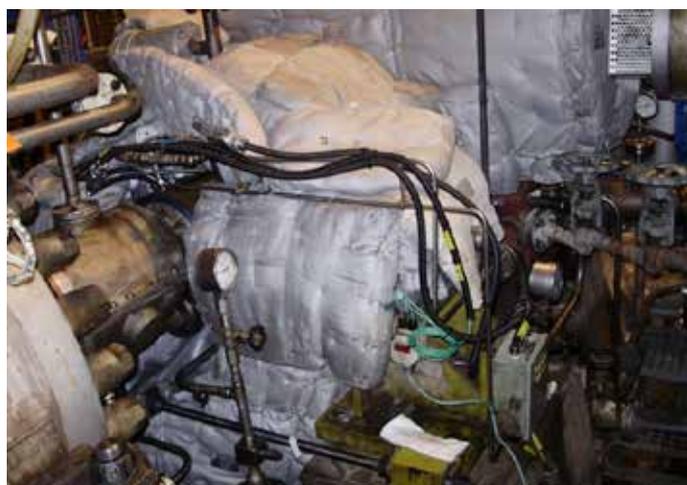
Figure 1: Turbine-driven compressor machine train

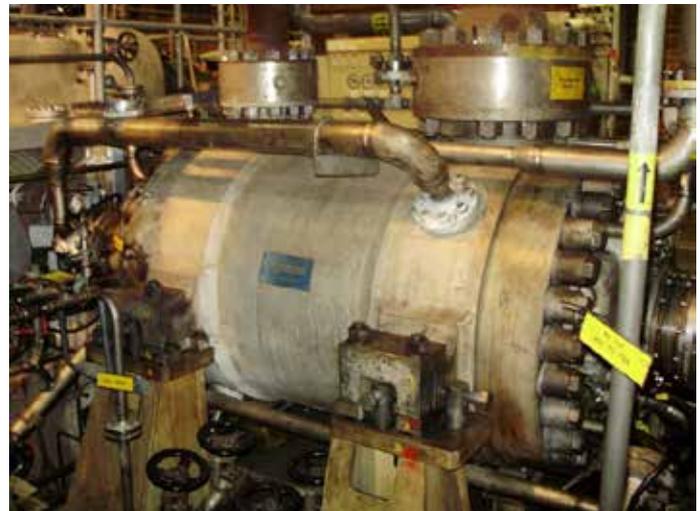
Figure 2: The steam turbine at BASF's Ludwigshafen, Germany site

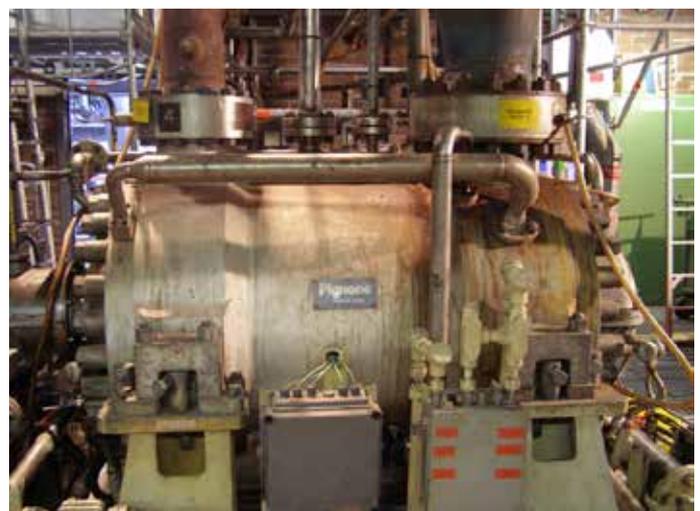
Figure 3: The intermediate pressure compressor, which was driven by the steam turbine, at the site
