APPLICATION NOTE

Bond Seam Inspection

Glue line and seam inspection for automotive body panels.

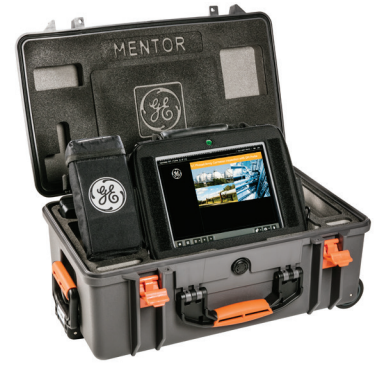
BHGE Inspection Technologies provides a non-destructive method for conducting bond seam inspections. The Bond Seam Scanner is easily clamped on body panels joined by a seam or other adhesive bonding process. The design enables the array to adapt to contoured parts commonly used in automobile designs. A spring-loaded encoder wheel provides a stable inspection platform and tracks the sensor position for bond lines up to 32 mm wide. A protection foil minimizes the need for couplant and facilitates manual scanning.

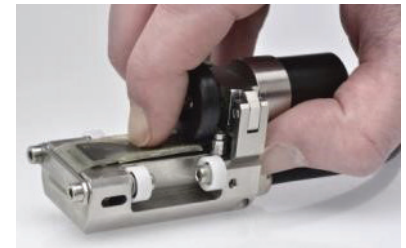
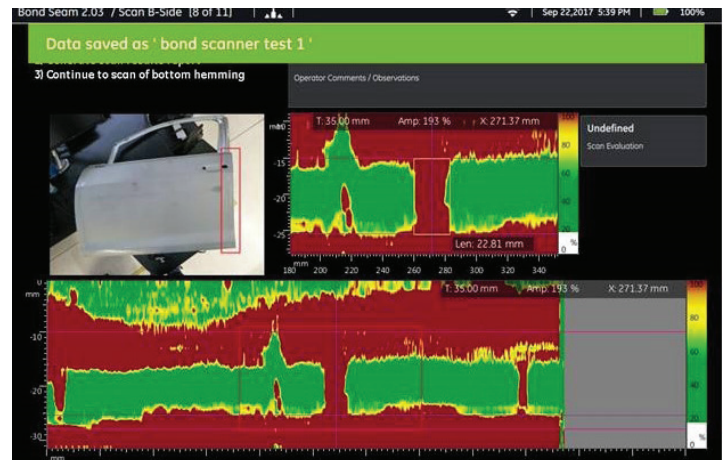
Green indicates strong adhesive bonding; Red indicates missing adhesive
Note areas of slight adhesive leakage

The innovative Bond Seam Scanner linear array design ensures inspection spatial resolution and detection resulting in an easily interpreted visual image of the presence of adhesive allowing the operator to evaluate the overall width of his bond seam and identify where adhesive requirements are not met.
